REPORT ON SYRIA

**United Nations Mission to Investigate Allegations of the Use of Chemical Weapons
in the Syrian Arab Republic**

**Report on the Alleged Use of Chemical Weapons in the Ghouta Area of Damascus
on 21 August 2013**

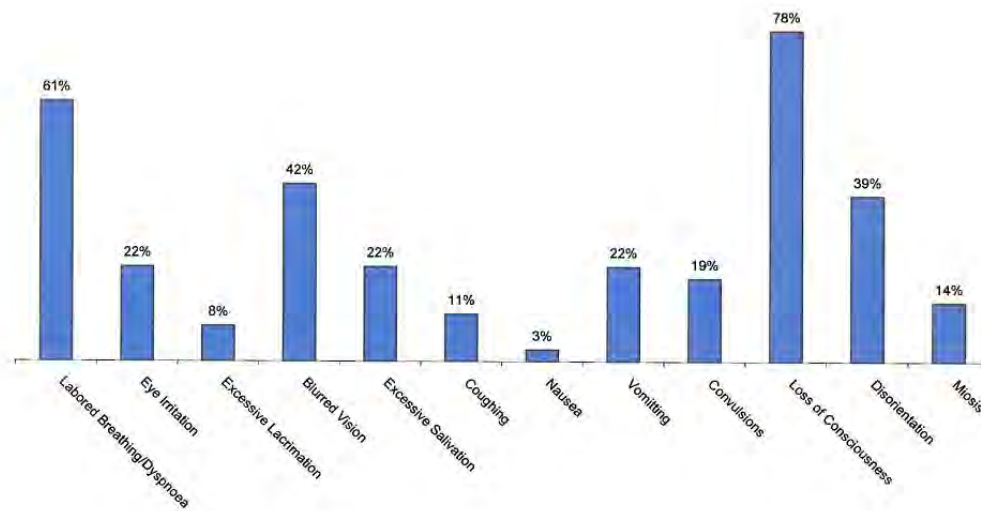
Chart: Symptoms and signs of survivors (N=36)

The main symptoms reported by survivors included loss of consciousness (78%), shortness of breath (61%), blurred vision (42%), eye irritation/inflammation (22%), excessive salivation (22%), vomiting (22%), and convulsions/seizures (19%). The full range of symptoms and signs are presented in the chart below.

Physical examination demonstrated that 39% of survivors were confused or disoriented at the time of the assessment and that 14% had miosis (constriction of pupils) (Figures 2 and 3).

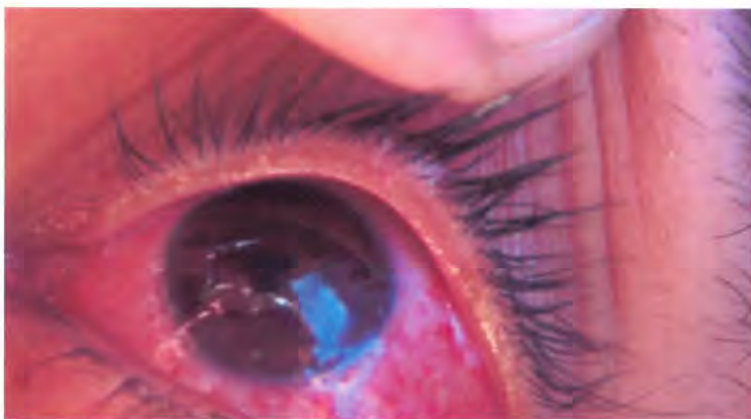
Figure 2: Miosis (constriction of pupils)

Figure 3: Inflammation of the eye

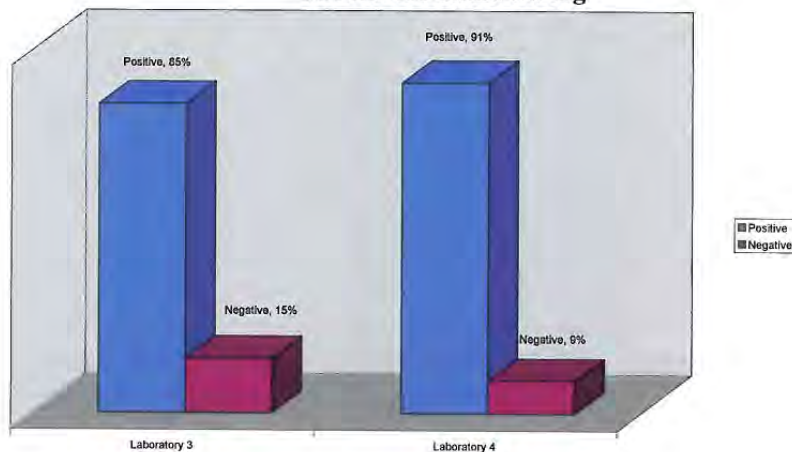
Results of Plasma testing

Table 2: Results of biomedical testing

Conclusion. The positive blood and urine specimens provide definitive evidence of exposure to Sarin by a large proportion of the survivors assessed by the investigation Mission. These results are corroborated by the clinical assessments, which documented symptoms and signs that are consistent with nerve agent exposure, including shortness of breath, eye irritation, excessive salivation, convulsions, confusion/disorientation, and miosis. The findings of the clinical assessments were consistent with information derived from both the interviews with clinicians and the review of medical records, which each reported symptoms and signs consistent with nerve agent exposure.

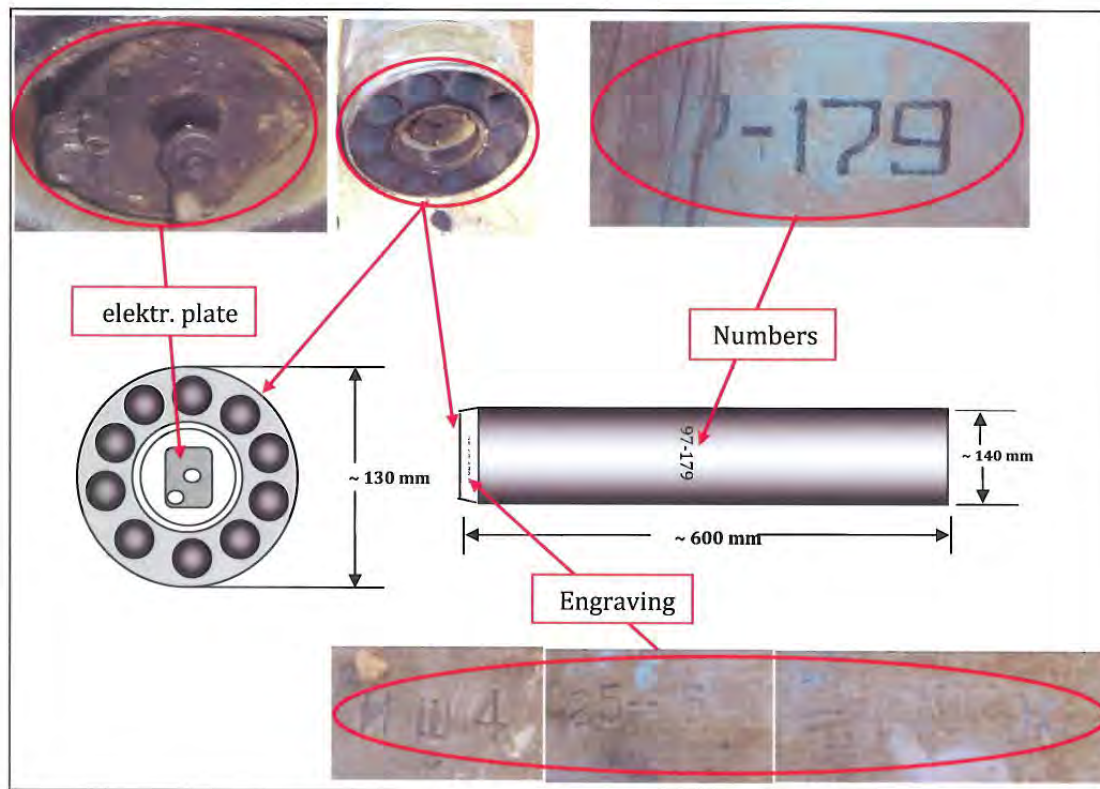
1. Black numbers on the outside: **97-179**
2. Engravings on the bottom ring of the engine: **Г Н III 4 25 - 6 7 - 179 K**

Length ~ 630 mm

Width ~ 140 mm

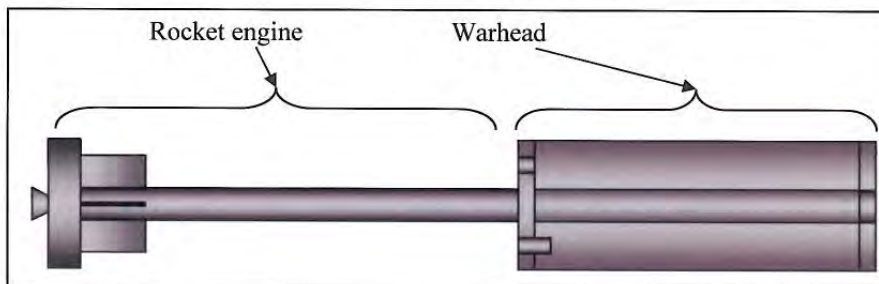
Below is a drawing of the found ordnance, the body has been divided into two parts.

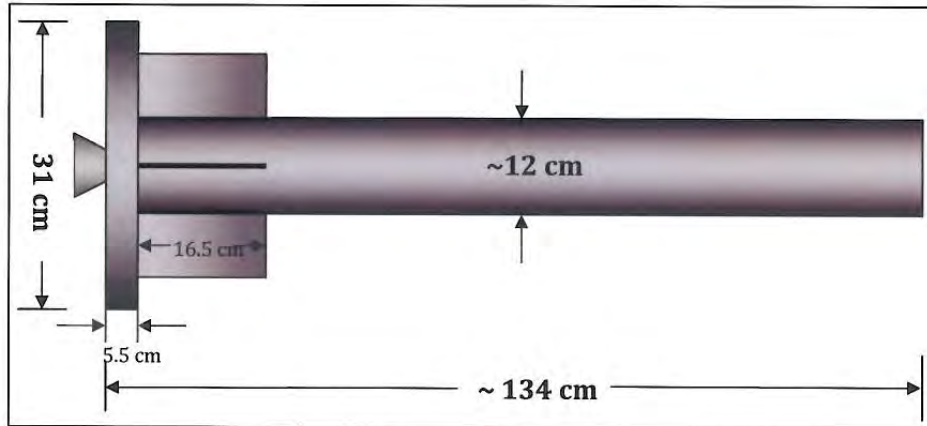
The rocket engine:

Six stabilizer fins are equally arranged in a circle and stabilized with a metal ring.

One rocket had a red number 153 sprayed in the middle of the engine tube.

The engine tube is attached to the warhead with 12 bolts.

- Total length of the engine: ~134 cm (exit nozzle not included)
- Length of rocket motor fins: ~16.5 cm
- Width of stabilizing ring: ~5.5 cm
- Length of motor exit nozzle: ~4.5 cm
- Length of motor engine shaft: ~112 cm
- $\varnothing$ of engine shaft: ~12 cm
- $\varnothing$ of stabilizer ring: ~31 cm

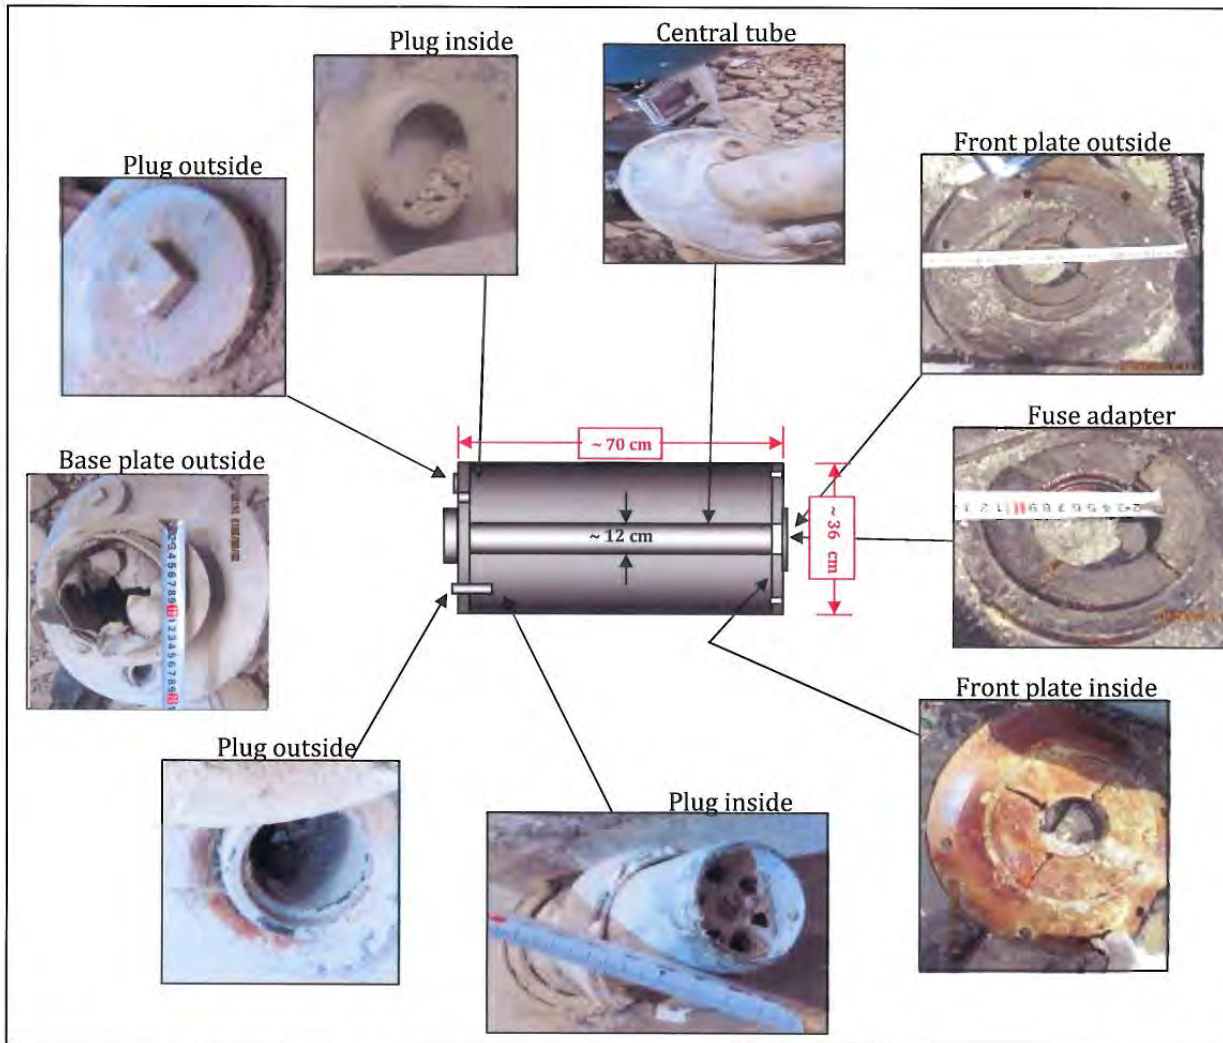
The warhead consists of:

- Front metal plate with a fuse thread in the center
 - $\varnothing$ outside: ~36 cm
 - $\varnothing$ fuse thread: ~9 cm

- Six threaded attachment holes are equally arranged in a circle near the outer ring
- Body / outer container consisting of metal plate
 - Thickness ~ 5 mm
- Metal base plate with filling plug, tube and attachment ring with 12 bolts.
 - $\varnothing$ outside: ~ 36 cm
 - $\varnothing$ square bolt ~ 7 cm
 - $\varnothing$ integrated tube on the base plate ~ 3 cm
 - Length of the tube ~ 10 cm
- Central tube of the warhead
 - Length of tube: ~ 70 cm
 - $\varnothing$ of the tube: ~ 12 cm
